## Finishes, Surfaces, and Trim

### **Original Construction and Evolution**

### **Existing Detrimental Conditions**

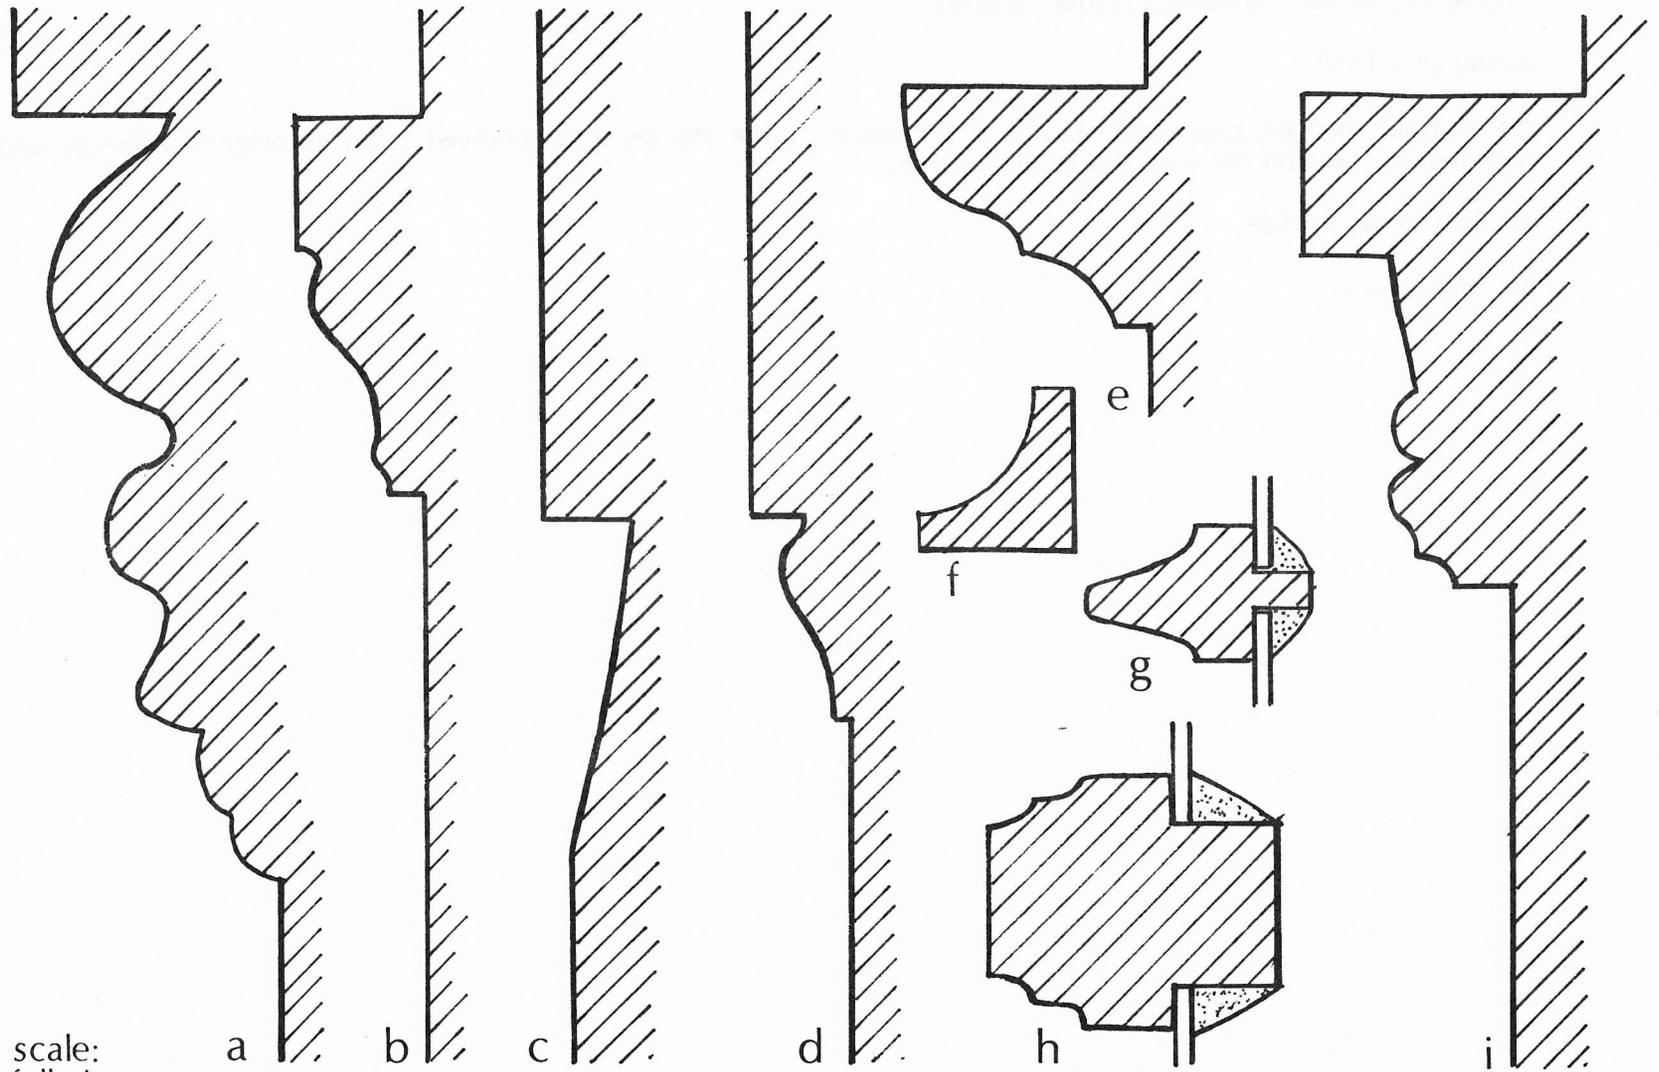
Figure 16. Arnold-Simonton House, Moulding Profiles

**Mouldings and Trim:** Interior mouldings and trim include baseboards and cove shoes, door and window facings, picture mouldings, and wainscot or dado trim. For moulding profiles see Figure 16.

- a. Column capital profile.
- b. Door face moulding.
- c. Beveled door panel profile.
- d. Door stile and rail profile at the panel.
- e. Picture mould.
- f. Cove moulding.
- g. Muntin for 6 over 6 window.
- h. Muntin for 2 over 2 window.
- i. Wainscot profile.

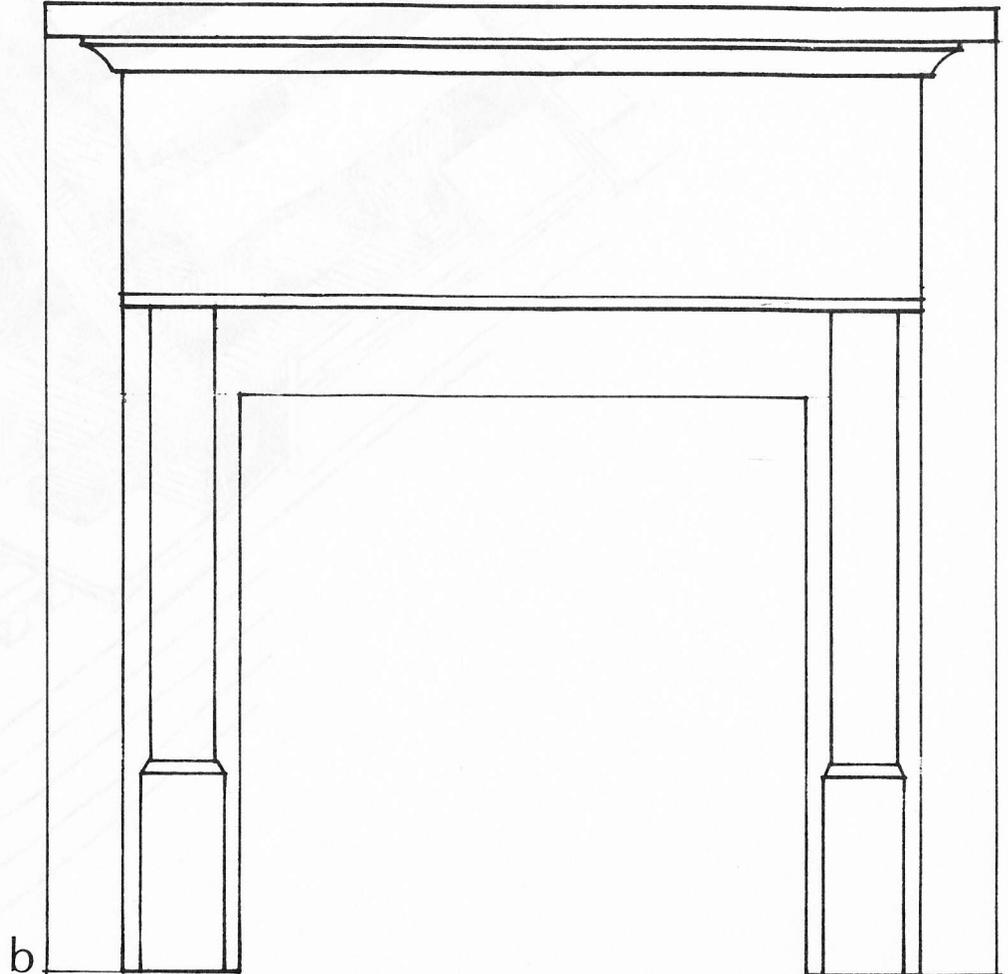
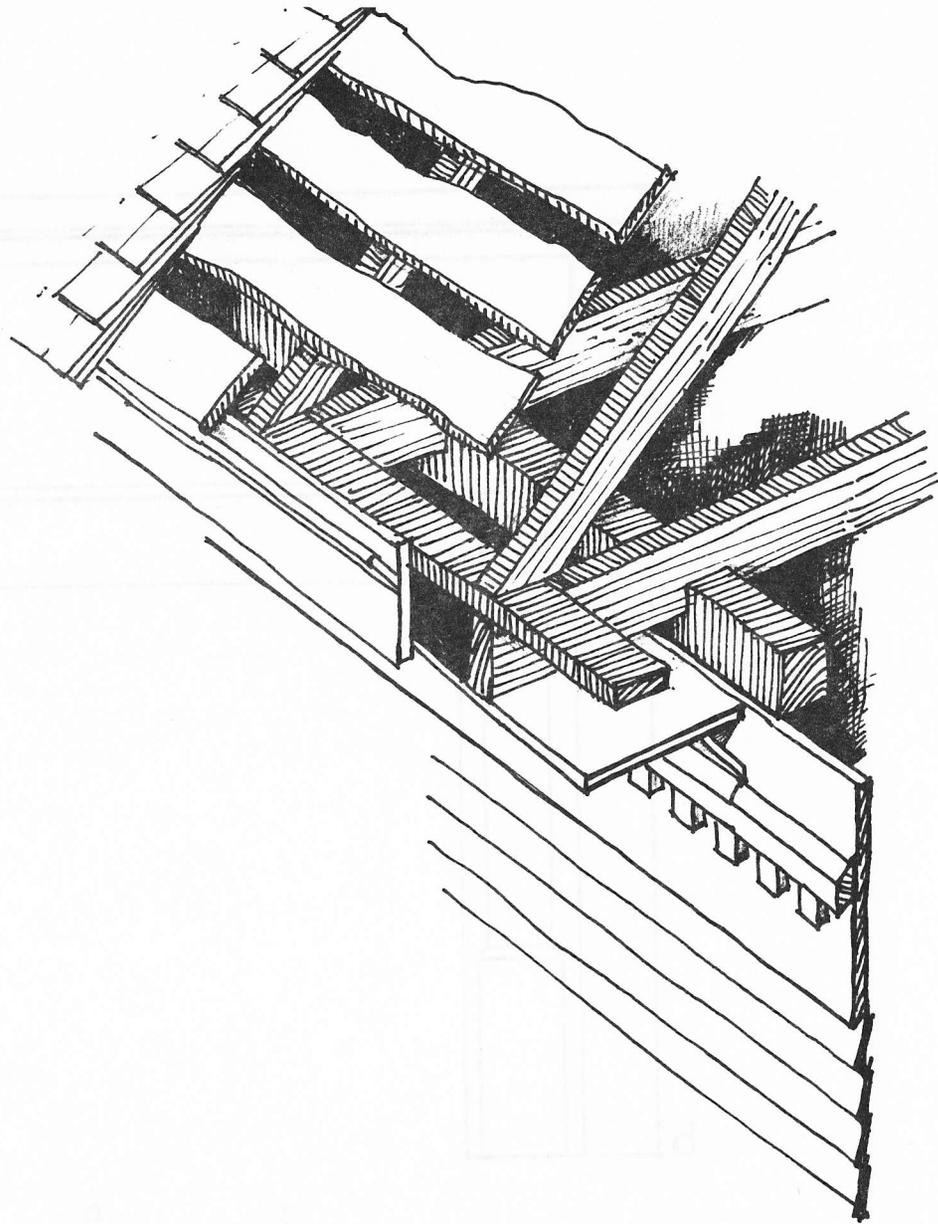
Figure 17. Arnold-Simonton House, Mantel

An original mantel, reportedly found in the attic of the House, was removed from an original chimney and installed in the east room of the 1930 addition.

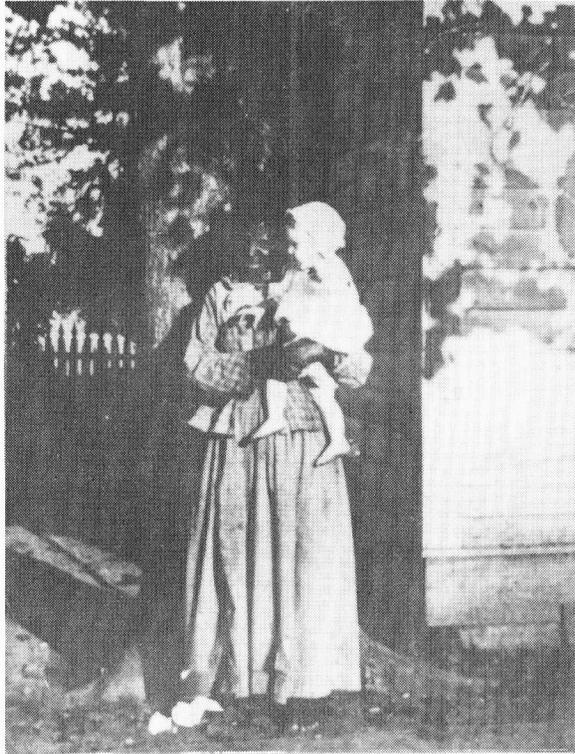
a. This photograph, probably made about 1910, shows that a watertable and skirt extended around the building at its base. The building appears not to have been raised high above grade. Photograph courtesy of Mrs. Vivian Furlow, Montgomery, Texas.

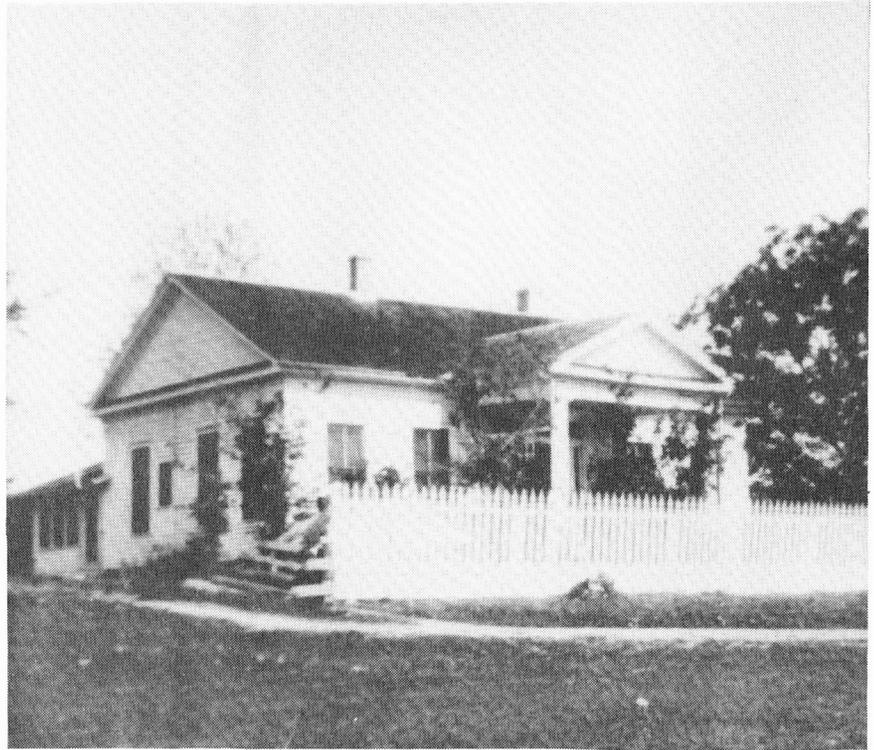
b

b. A photograph which may date from the 1930s shows one original chimney intact and a flue chimney at the ridge. The flue chimney probably served a wood stove located in the central hall. Photograph courtesy of Mrs. Vivian Furlow, Montgomery, Texas.
