## Finishes, Surfaces, and Trim

### **Original Construction and Evolution**

### **Existing Detrimental Conditions**

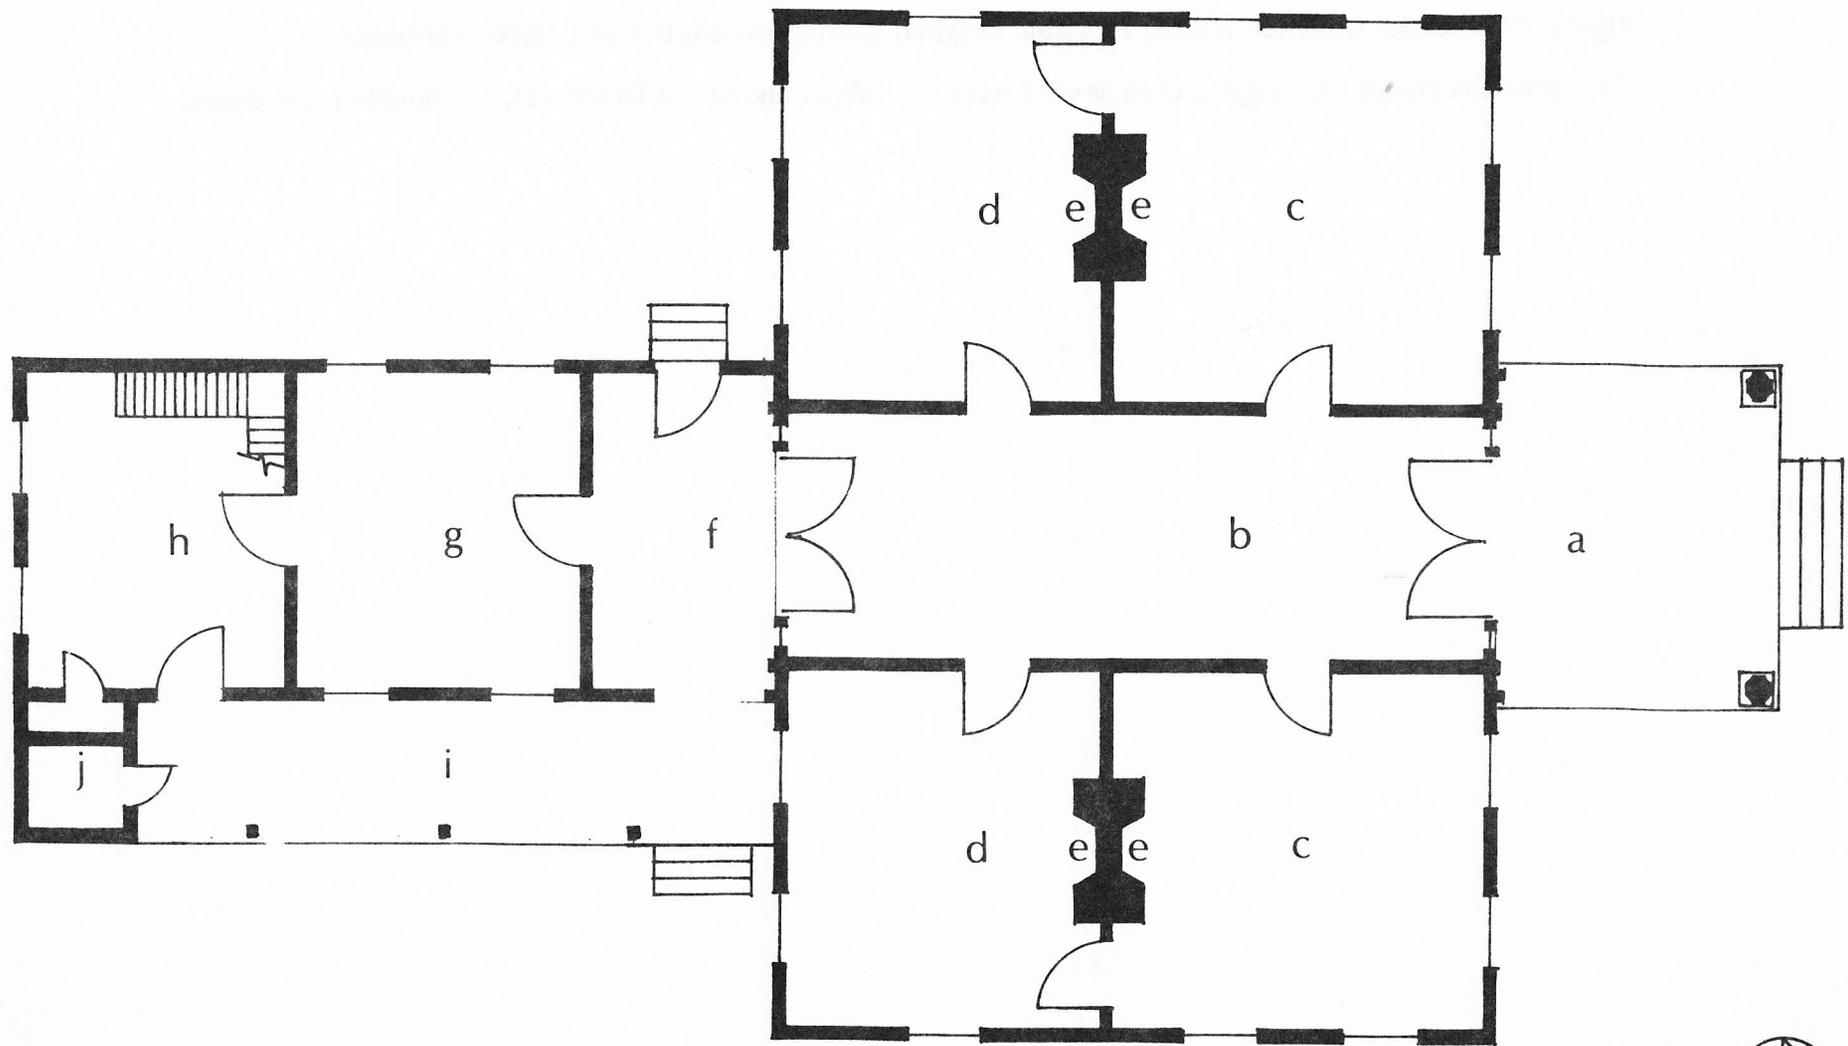
Figure 19. Arnold-Simonton House, Original Floor Plan

- a. Portico.
- b. Central hall.
- c. Front room.
- d. Back room.
- e. Fireplaces.
- f. Breezeway.
- g. Dining room.
- h. Kitchen.
- i. Porch.
- j. Pantry.

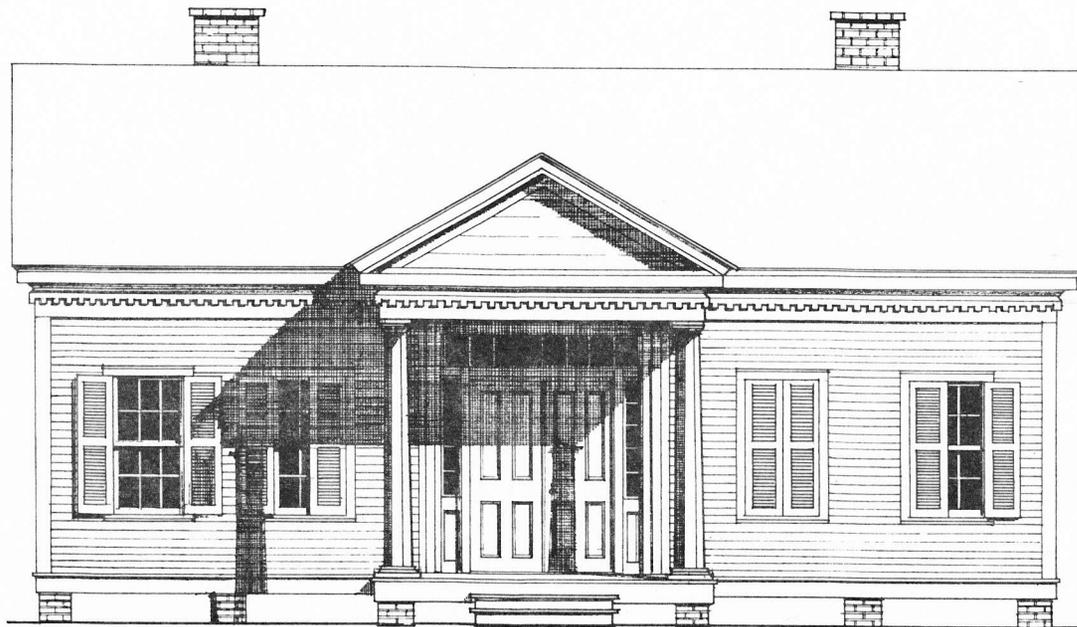
Figure 20. Arnold-Simonton House, Probable Original Configuration, Present North Elevation

The elevation shows the original chimneys, 6 over 6 windows and blinds (shutters), and double front doors.

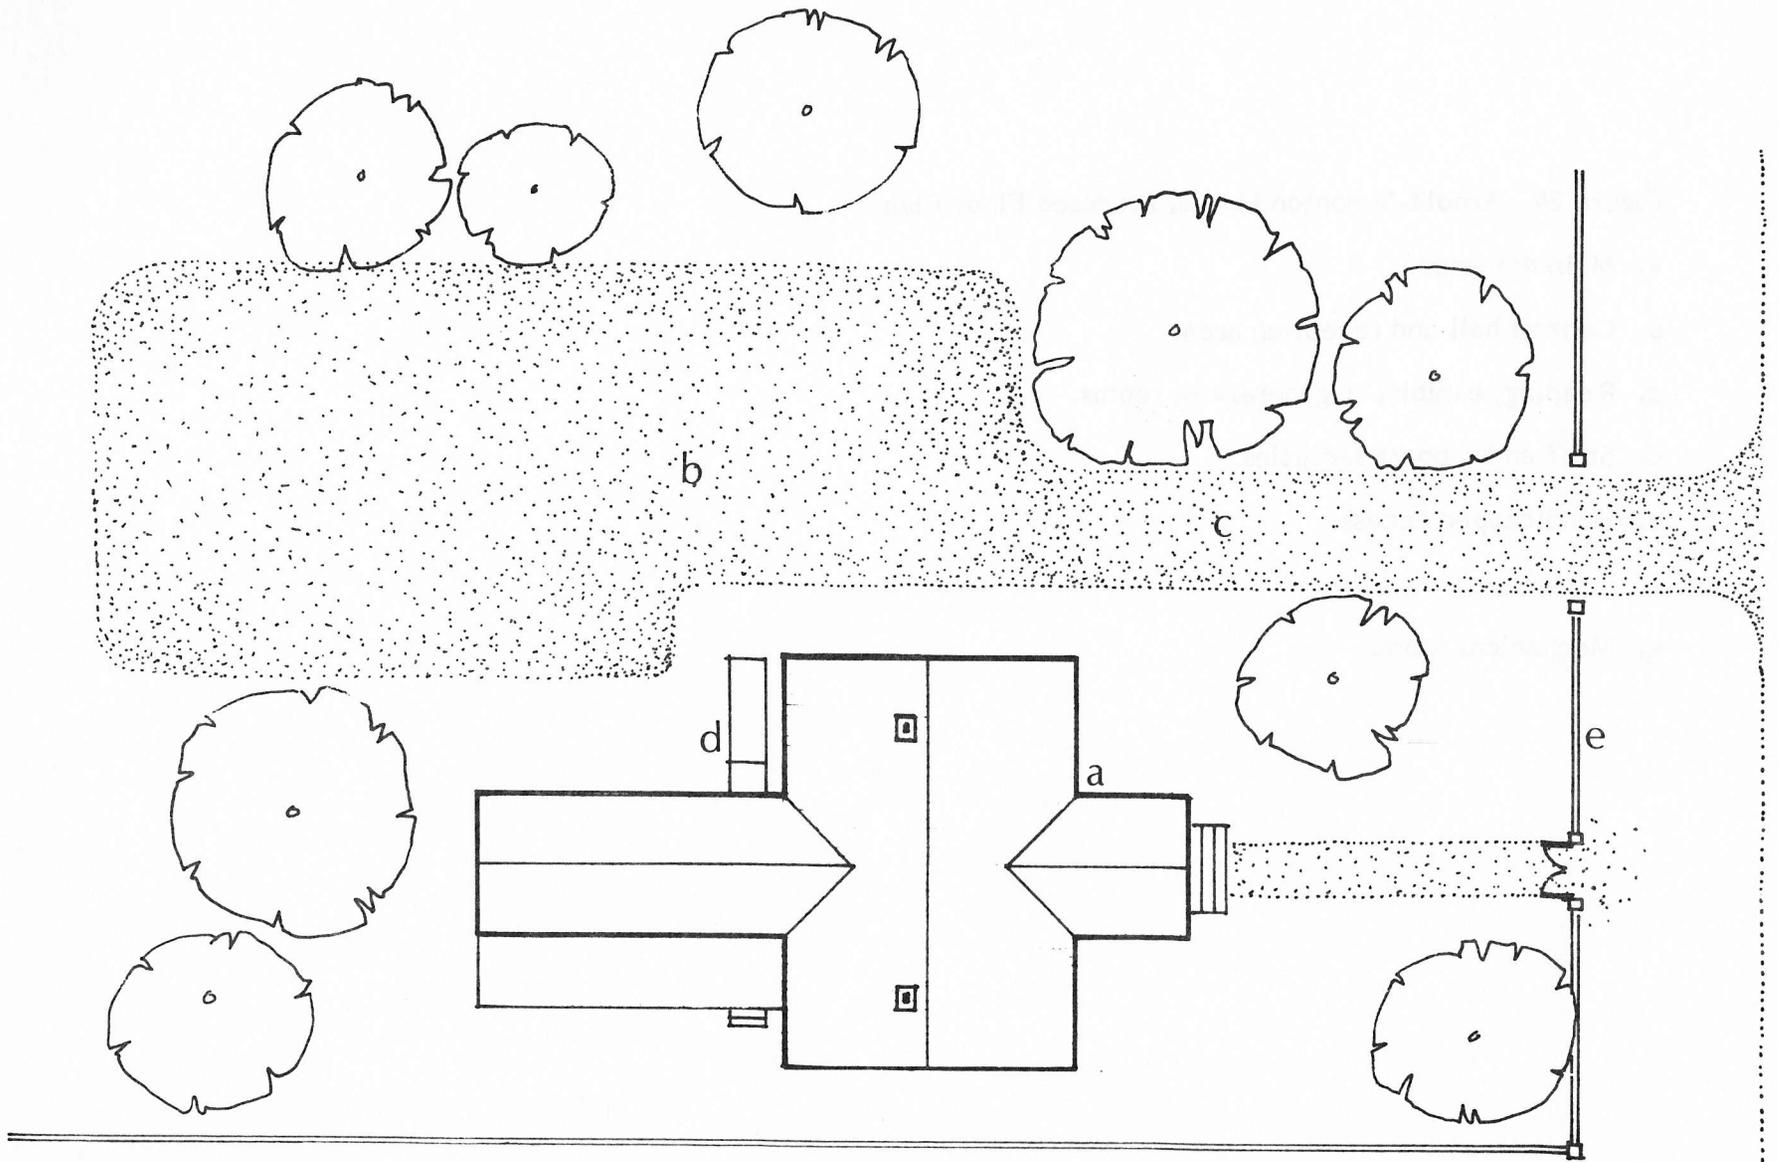
Figure 23. Arnold-Simonton House and Property, Proposed Site Plan

- a. Arnold-Simonton House
- b. Parking lot.
- c. Access.
- d. Handicapped access.
- e. Fence.

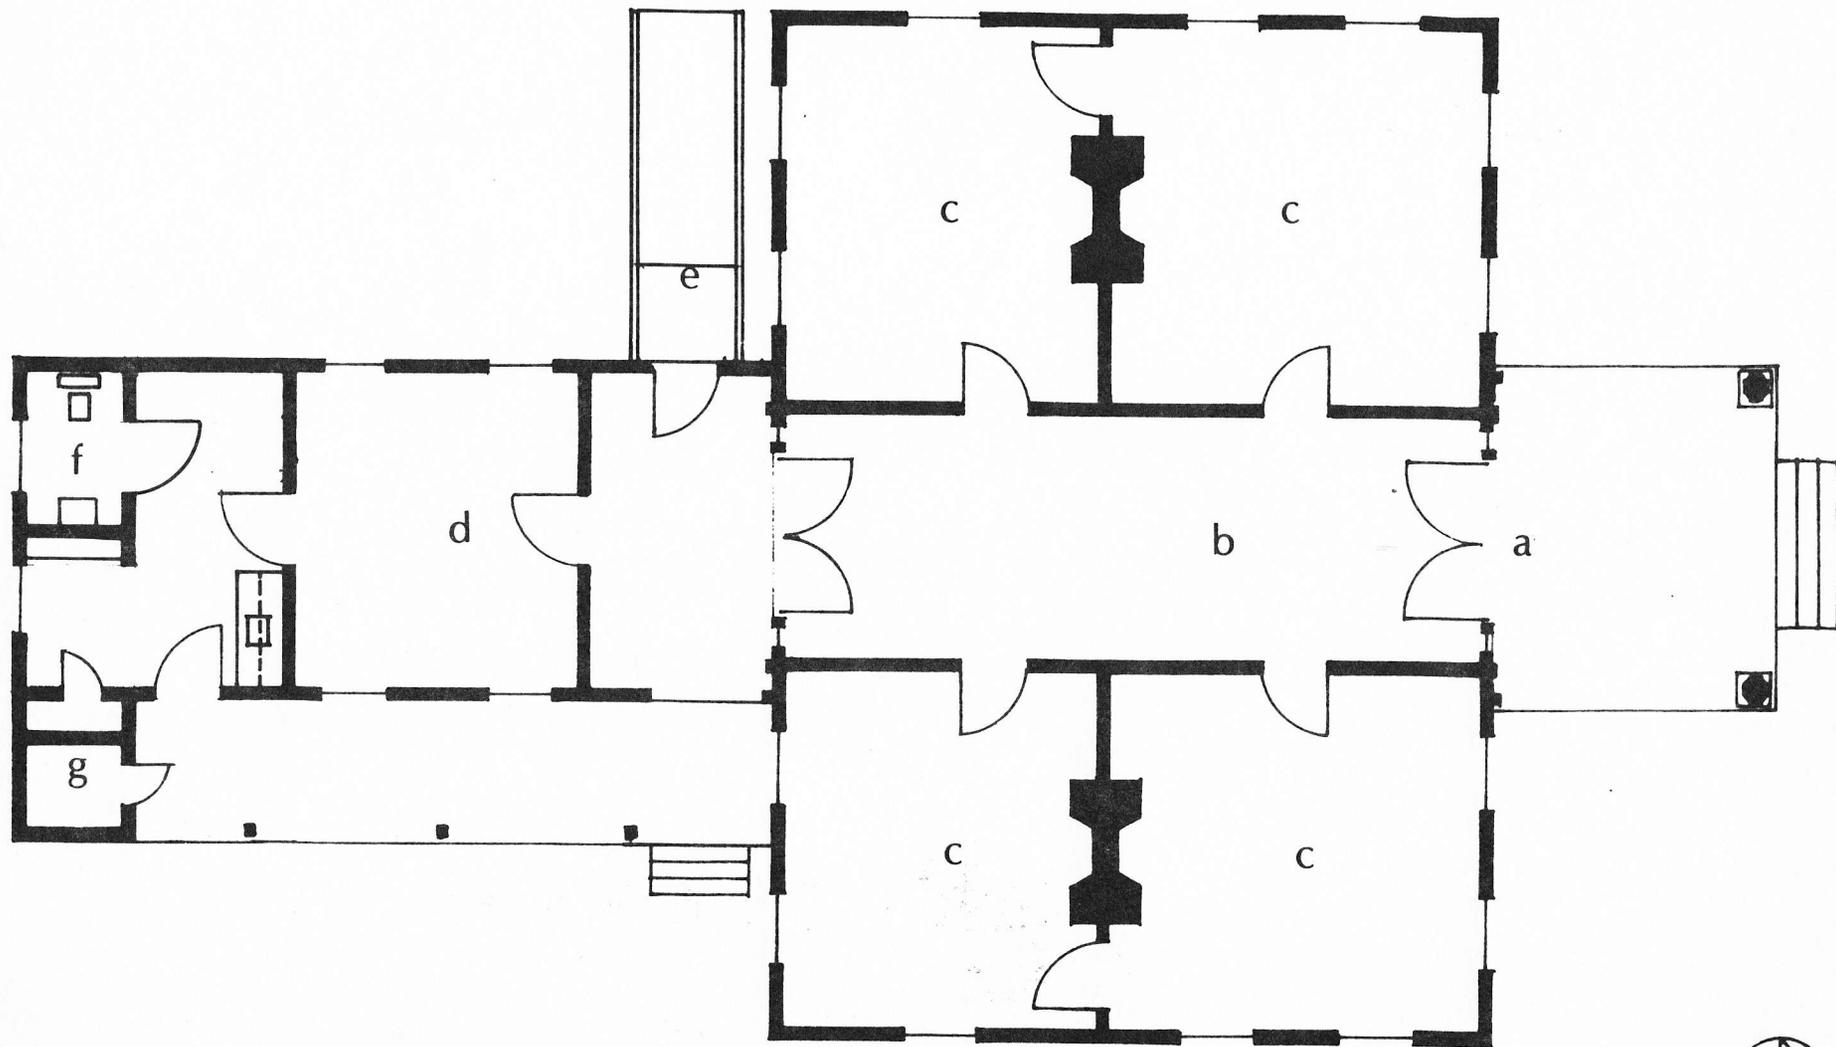
Figure 24. Arnold-Simonton House, Proposed Floor Plan

- a. Main entrance.
- b. Central hall and reception area.
- c. Reading, exhibit, or general-use rooms.
- d. Staff and support facilities.
- e. Handicapped access.
- f. Restrooms.
- g. Mechanical room.
